Facilities, Maintenance and Grounds:

Lake and Fishing Areas:

Lake Filter test

UV Filter test

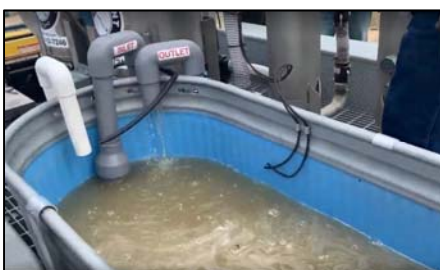
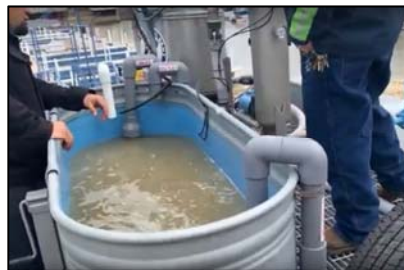
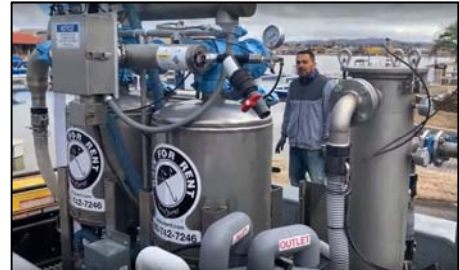
We started the test by putting 150 gallons of lake water into a containment, this 150 gallons was filtered at a rate of 20 to 70 gpm (gallons per minute). The first test lasted for about 30 minutes filtering using only the sand/gravel filtration and the 150 gallons was filtered about 6 times before it was concluded unsuccessful. This test did remove any other sediment in the water but not the diatom. The second test added a 5 micron bag and was concluded unsuccessful after 10 minutes and filtering the 150 gallons about 2 times. The third test added a ½ micron cartridge filter and was concluded unsuccessful after 10 minutes and filtering the 150 gallons about 2 times.

This test was not as successful as we needed it to be so we are back onto centrifuge filtration and looking for other filter testing unit. This is an alternative to chemical treatment and still in the exploration and testing phases.

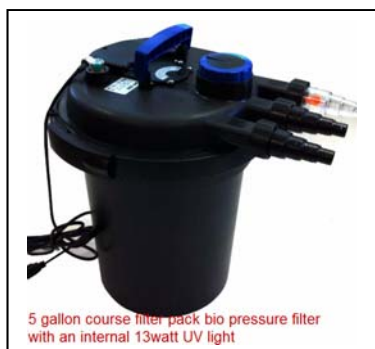
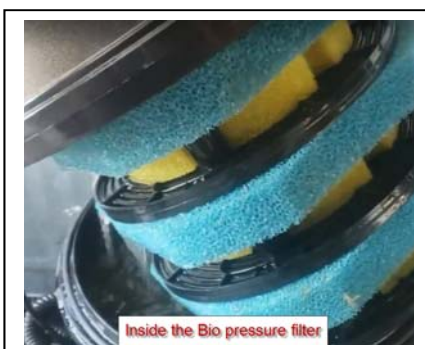
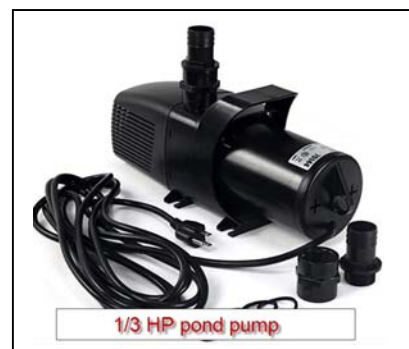
1st UV filter test hardware

The first test which was started on April 19, 2019, consisted of a 5 gallon coarse filter pack bio pressure filter with a 13watt UV light and a 1/3hp pump. The test conduct with pumping 150 gallons of lake water into a container. We then circulated the 150 gallons through the filter at 10gpm and until clarity of over 8' was achieved, this test did this within 72 hours. We retrieved approx. 9cu.in. of diatom material when the test was concluded. This test not only removed all of the diatoms algae but also other algae's, it removed 93% of Nitrogen, 90% of Phosphorus it cleared the water by 95%, creating healthier lake water for the eco system.

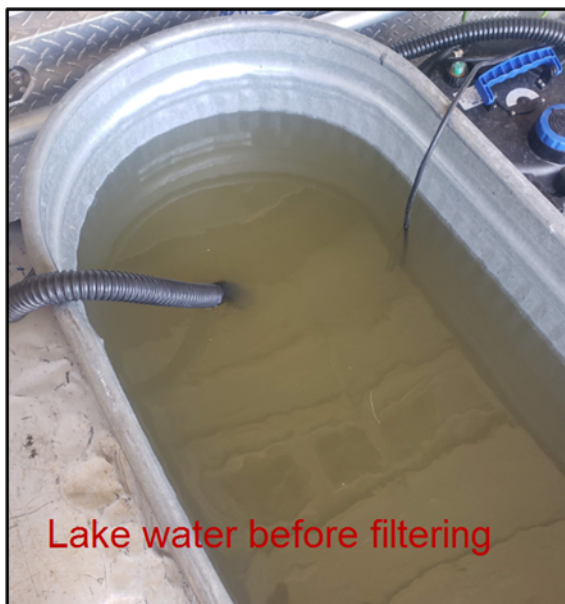
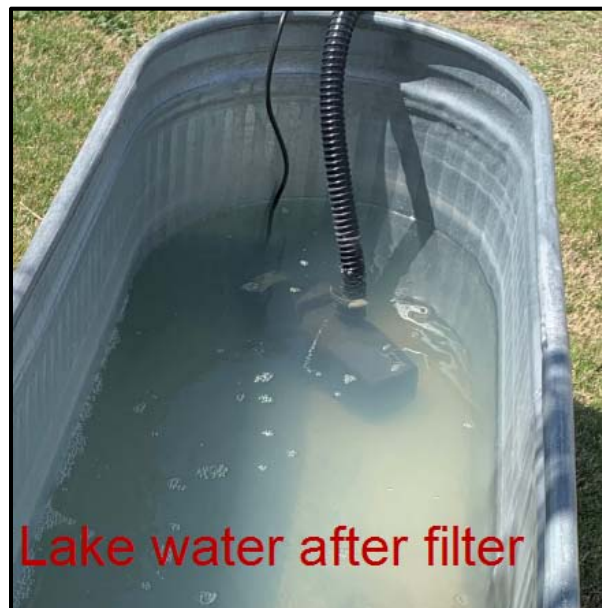
1st UV filter test results

SPRING VALLEY LAKE ASSOCIATION - filter test April 19, 2019			
FILTER: CPF-180/250 UV-C POND BIO PRESSFILTER AMOUNT: TESTED 150 GALLONS			
PUMP SPEED: 30GPM		DURATION: TEST RUN WAS 72 HOURS	
Analysis	Filtered water	Lake water	Description
Synedra sp. (algae) cells/mL	< 40	< 400	Single-celled planktonic
Cynbella sp. (algae) cells/mL	< 40	< 400	Colonial planktonic
Eunotia sp. (diatom) cell/mL	not detectable	335,000	other algae found below 400 cells/mL, Scenedesmus, Pediastrum, Aulacoseira
Total Phosphorus ug/L	23.80	339.80	FILTERED: Moderate amount-Mesotrophic LAKE: High amount - Hypereutrophic
Free Reative Phosphorus ug/L	< 5	< 5	Low
Total Kjeldahl Nitrogen mg/L	0.60	2.80	FILTERED: Low LAKE: Moderately high
Nitrate & Nitrites mg/L	< 0.02	< 0.02	lower than measurable factor
Nitrogen mg/L	0.60	2.80	FILTERED: Low LAKE: Moderate
Cholorophyll a ug/L	< 10	11.30	FILTERED: Low LAKE: Moderate
pH	6.90	6.90	Near Neutral

Dissovled Oxygen mg/L	7.50	7.80	Accetable for freshwater
Conductivity uS/cm	323.00	323.00	Typical for freshwater
Alkalinity mg/L	94.00	95.10	FILTERED: Moderately buffered LAKE: Moderately buffered
Hardness mg/L	77.30	78.00	FILTERED: Moderately hard LAKE: Moderately hard
Turbidity NTU	5.90	86.10	FILTERED: Moderate LAKE: High amount

Although this test was successful we wanted to scale this test up using a higher wattage UV bulb to confirm that the results can happen more efficiently.

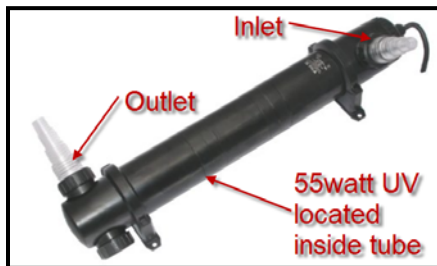
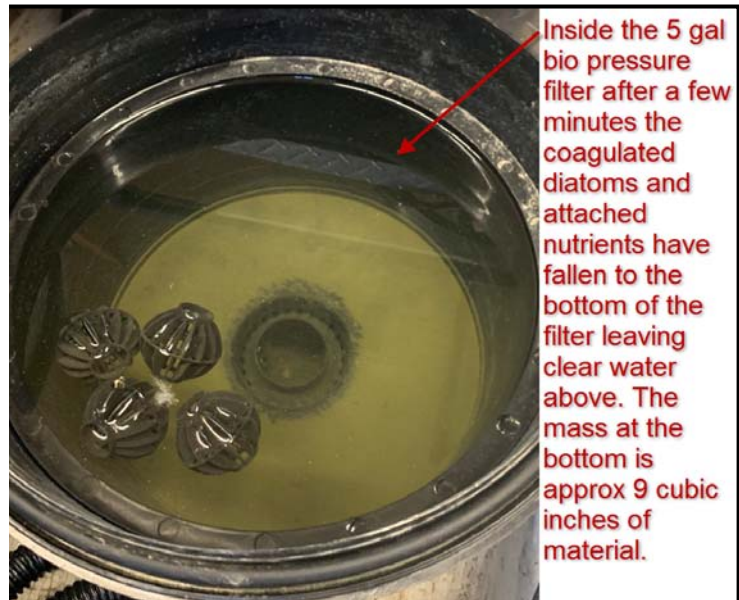
The second test which was started on May 2, 2019, consisted of the same 5 gallon course filter pack bio pressure filter with a 13watt UV light and a 1/3hp pump, but we added a 55watt UV light. The test conduct with pumping 150 gallons of lake water into a container. We then circulated the 150 gallons at a rate of 10gpm until clarity of over 8' was achieved, this test did this within 20 hours. We retrieved approx. the same 9cu.in. of diatom material when the test was concluded. This test also not only removed all of the diatoms algae but also other algae's, it removed 93% of Nitrogen, 90% of Phosphorus it cleared the water by 95%, creating healthier lake water for the eco system, the results also confirmed that a quicker and more effective time can be achieved with increasing the wattage of the UV filter. The filter and pump systems was the same components as shown in test 1 except with the addition of the 55watt UV shown below.

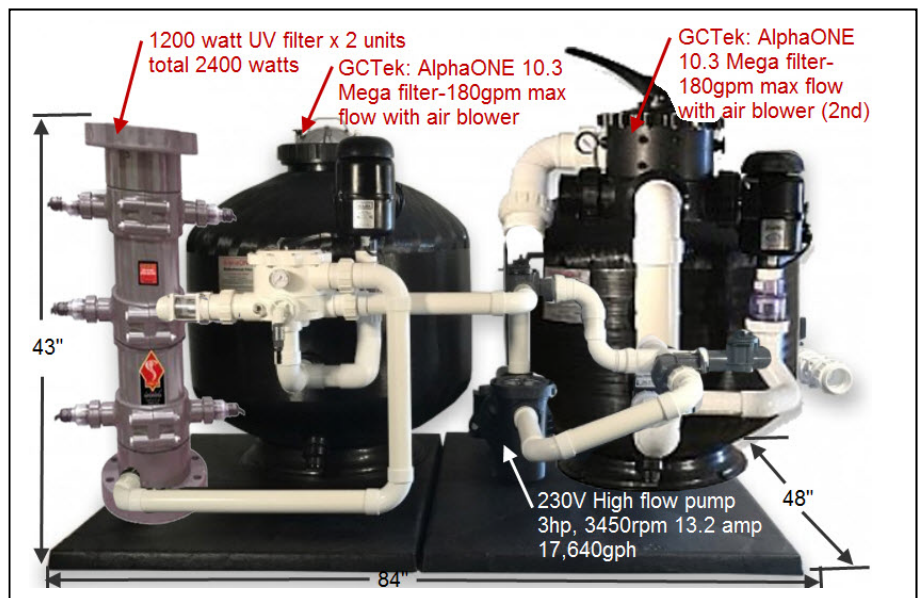
Based on the results from the UV filter test and ability to scale the test up with the same results we have designed a solution system. This system is built to maximize the filtering requirements but stay within power restrictions we currently have at the area these unit can be placed. The filter systems would be placed at each of the 14 fishing areas, at the marina and east beach for a total of 16 systems. These filter systems are designed compact enough not to impede the aesthetics or use of each area with a foot print of only 7' x 4' and enclosed within a nice equipment box this system could run 24/7 with minimal noise until lake clarity is achieved and then timed to keep the lake controlled. The upscale will consist of 2-77 gallon bio pressurized filter packs, 2-1200watt UV filters and 1-3hp high flow pump. This system would be able to filter approx. 290 gallons per minute or 417,600 gallons per day. The

cost of each unit is projected to be \$25,800.00 complete with enclosure. The projected cost to run this filter 24/7 is \$81.08 per year. The inlets would require 2 inlet points approx. 25' to 40' apart that will provide safety from accidental suction lock. It will not allow a person to get stuck on 1 inlet. The inlets will also be strained and be fully adjustable to filter water from any depth. 1 inlet will be a surface skimmer type using 3-12" orange buoys holding the inlet just below the surface but adjustable to 18" below the surface. The 2nd inlet would be set around 24" from the surface and can be adjusted from 2' to the bottom. The discharge or return flow could be used as a water feature or discharged near the bottom away from the inlets. The diagrams below show a standard installation at the marina, but a similar installation would be the same at any area.

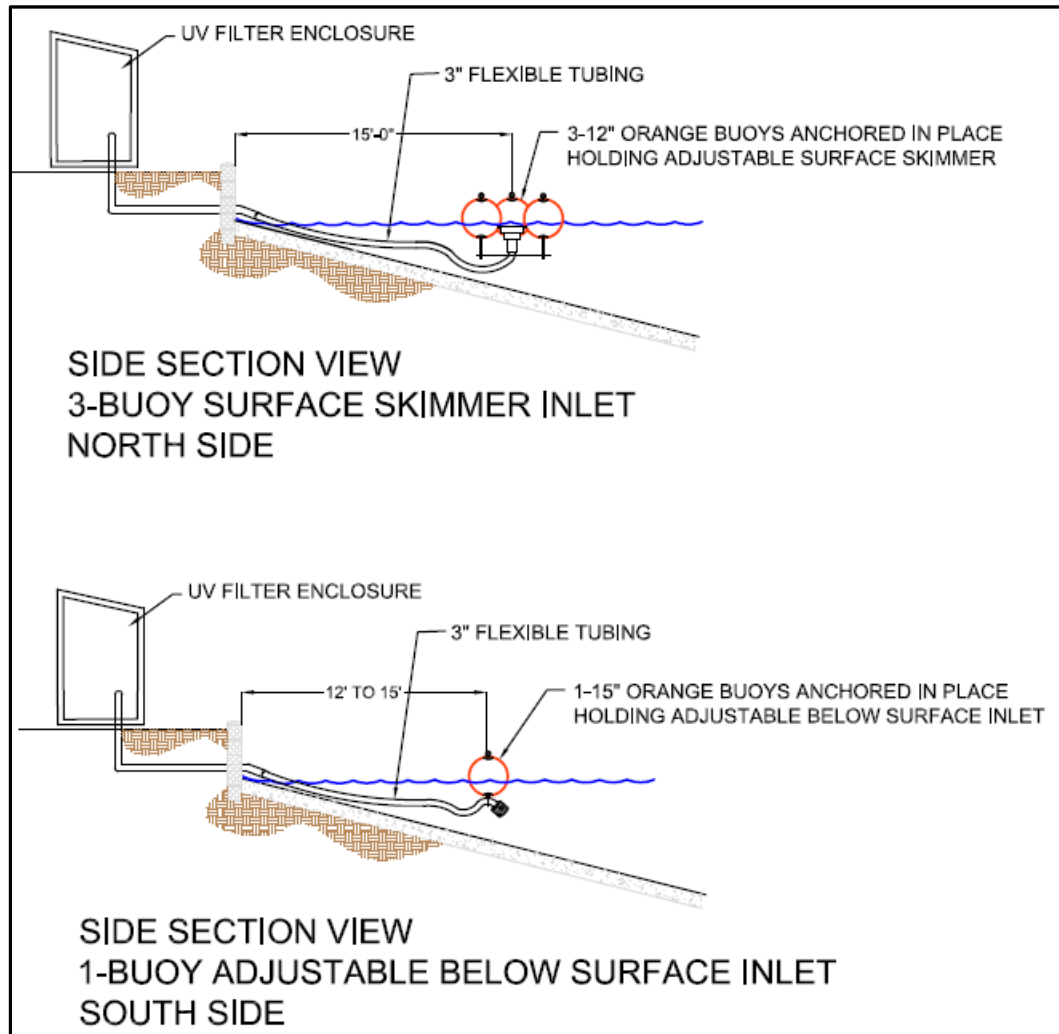
This illustration below shows the side section views of the inlets for reference.

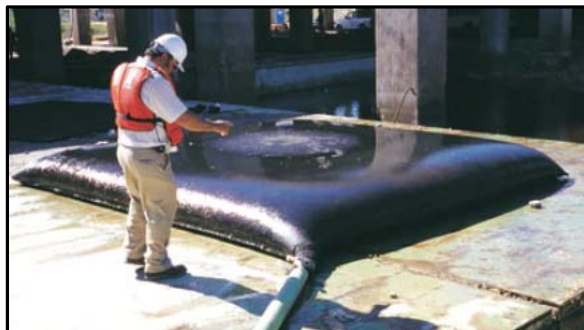
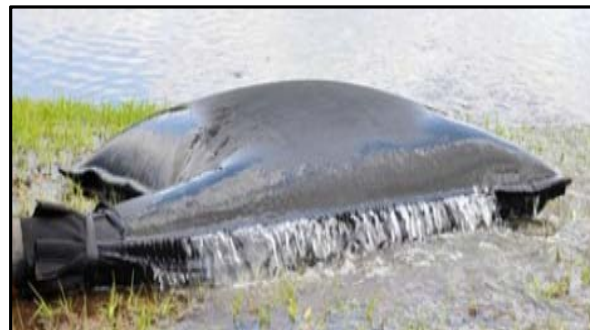
Maintenance would require checking the system daily and back flushing the system every 1 to 3 weeks. This process of back flushing would require back flushing the system in to a 10' x 15' filter bag (150 cuft.) into a dewatering filter bag and allowing the filter bag to keep the diatom material and clean water to flow back into the lake. This process would take about 30 minutes at each filter station. The bag would be placed on a barge where the back flushing would take place. The bag would sit for 24 to 48 hours prior to disposing of the diatom material. It is determined that 66 to 132 bags will be required to remove all of the 10,000cuft to 19,913cuft of diatom material from our lake. The dewatering filter bag is shown below.
