Spring Valley Lake Association

Operations Report May 28, 2013

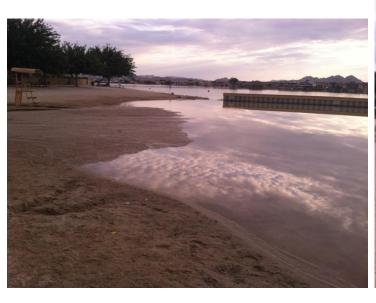
• Repaired a 5" line from well 16, that split and moved approx. 15 tons of dirt and sand into the swim area. The repair was made and beach cleared that day and was re-opened the following day.
